HISTORIC STRUCTURE REPORT

FORT MATANZAS NATIONAL MONUMENT
ST. JOHN'S COUNTY, FLORIDA

THE FORT MATANZAS STABILIZATION TEAM

DENVER SERVICE CENTER
SOUTHEAST/SOUTHWEST TEAM
HISTORIC PRESERVATION BRANCH
NATIONAL PARK SERVICE
UNITED STATES DEPARTMENT OF THE INTERIOR
DENVER, COLORADO

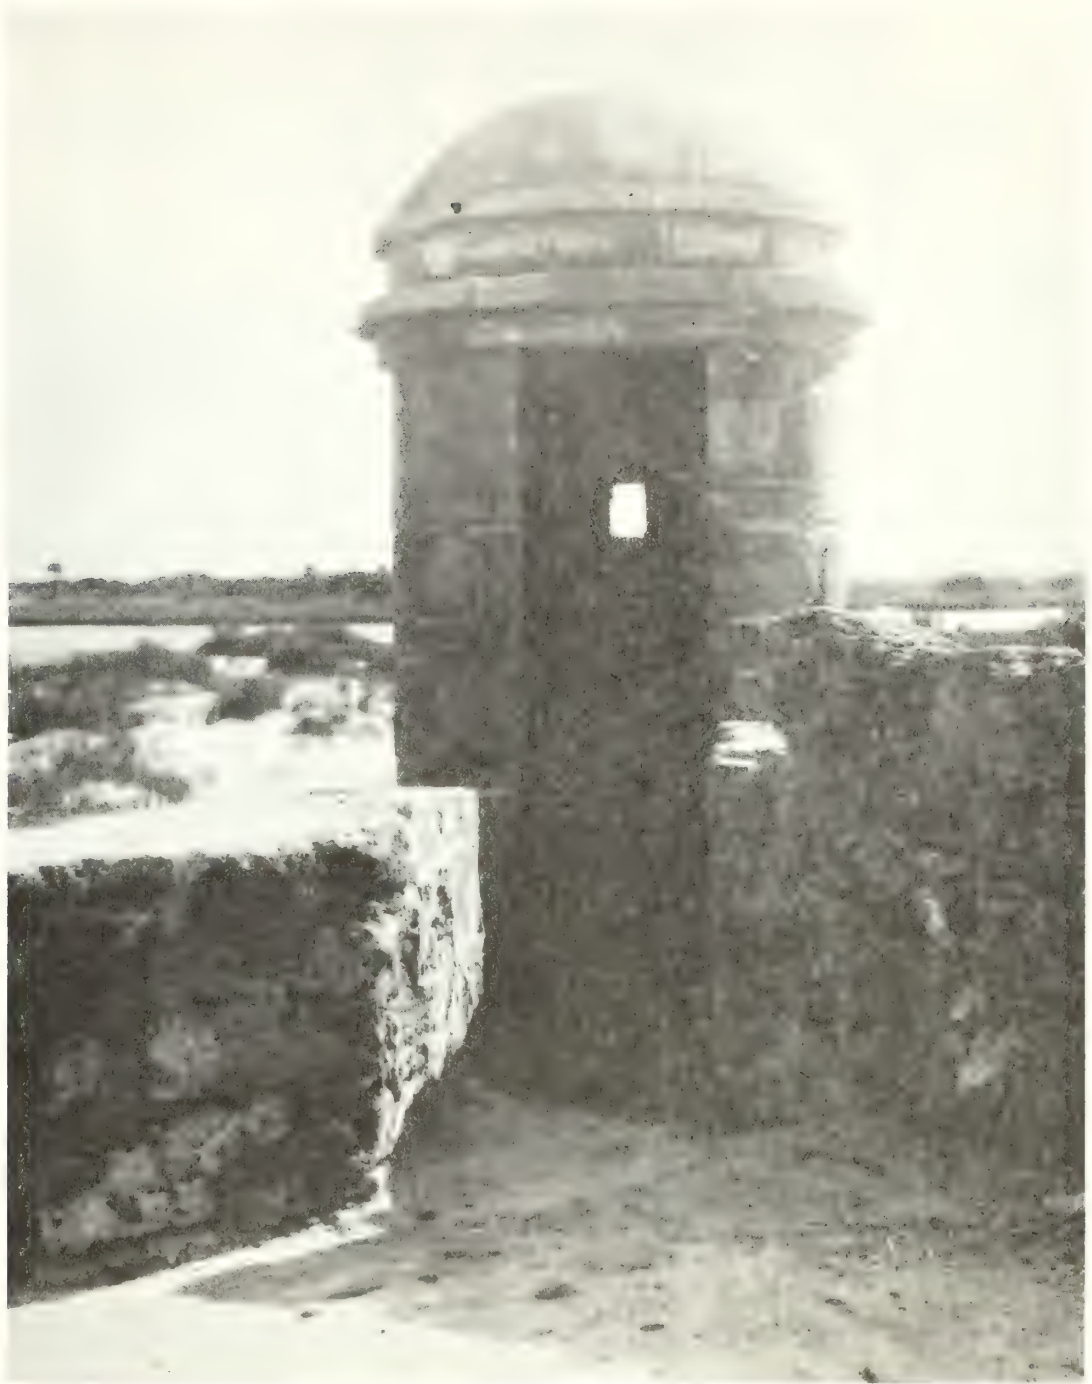
Illustration D-22

View of 1929 Reconstructed Sentry Box from Terreplein, (Photo M-381)

Notice the iron lintle ring visible at the doorway which has deteriorated and is no longer present.

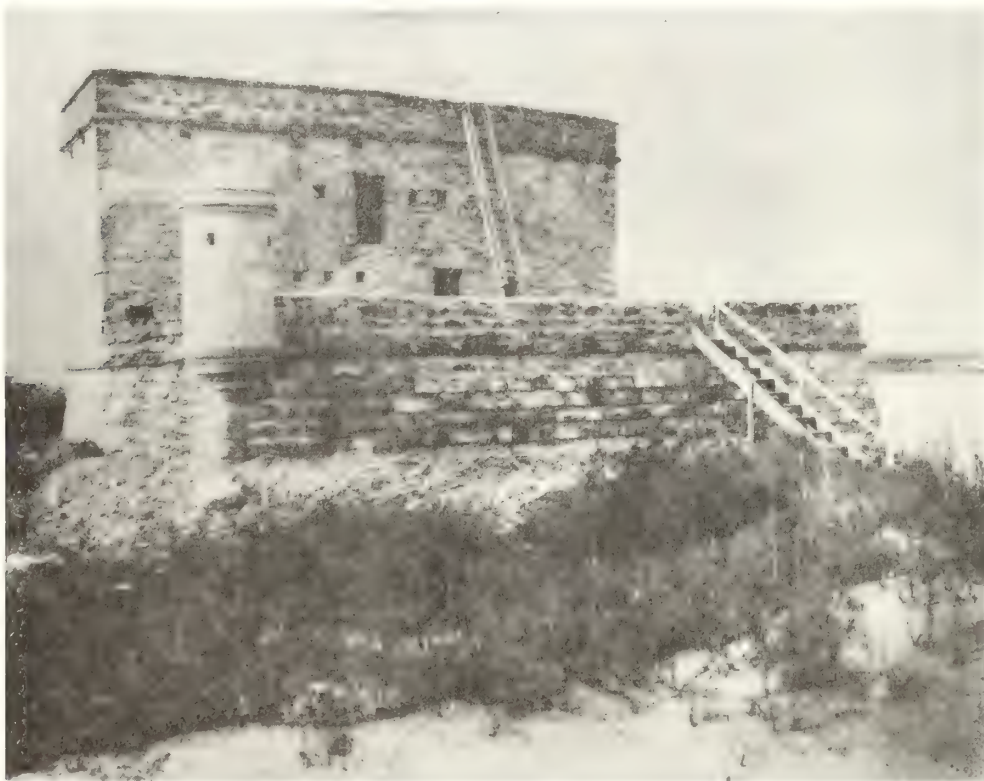
Illustration D-23

View of Fort with Oyster Shell Protection at Base and New Access Ladder with Second Reconstructed Sentry Box, 1933, (Photo M-246)

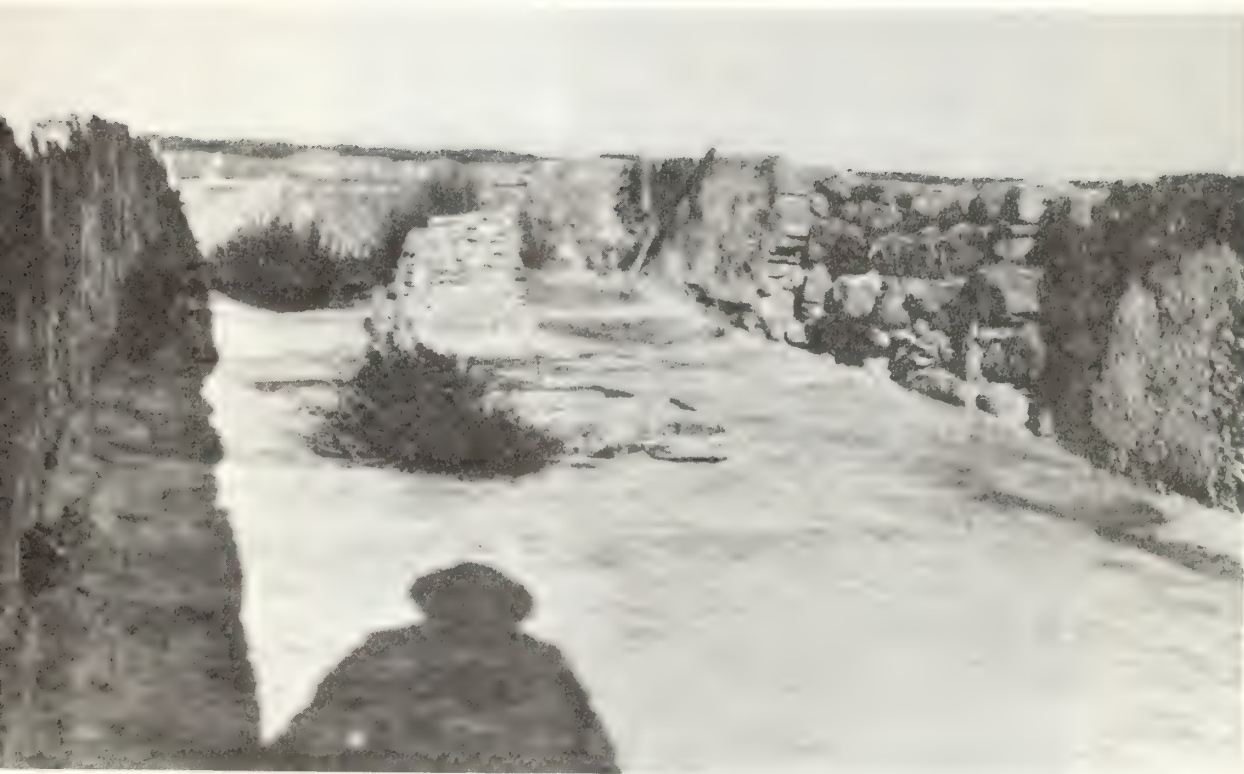
Illustration D-25

View of Tower Roof, 1934, (Photo M-798)

This photograph, taken about 1934, shows the problems of the tower roof: vegetation growth, cracks and poor water drainage. Notice the height of the chimney flue compared to today's low curb.

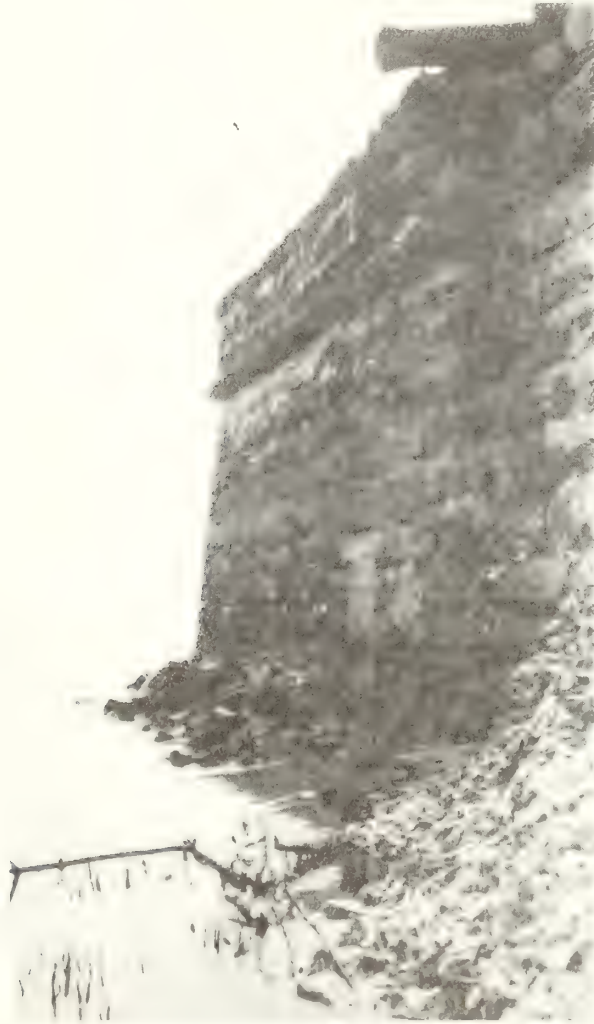
Illustration D-27

View of Matanzas River at Base of East Scarp of Fort, circa. 1935, (Photo M-812)

This picture (as well as D-26 and D-28) was probably taken about the same time as the 1935 erosion report. It illustrates the danger of undermining which has begun due to the wave action of the Matanzas River. At right, remains of the 1924 oyster shell protection which has been completely removed from the base of the southeast scarp.

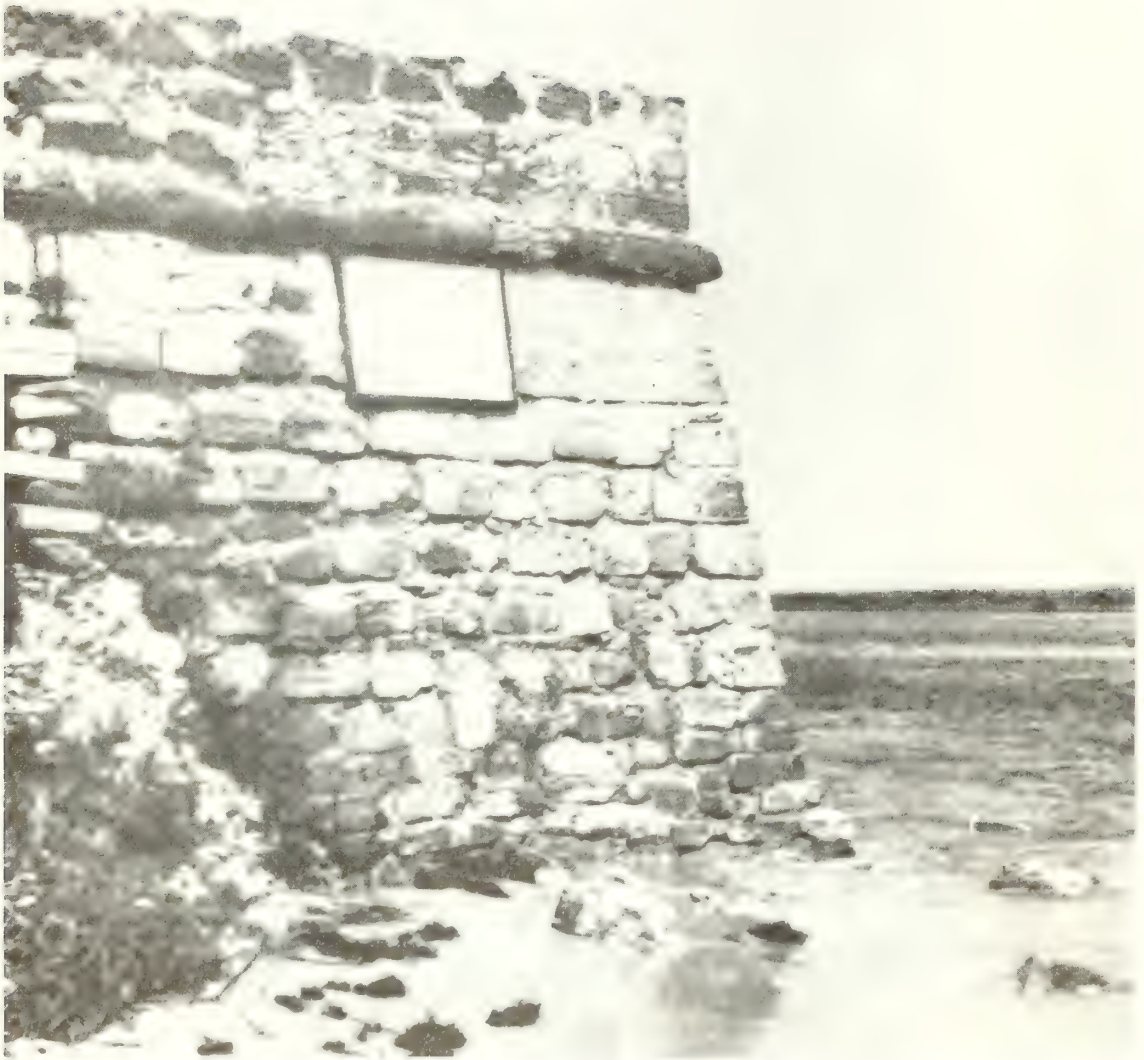
Illustration D-28

Southeast Salient of Fort Washed by River, October 1936, (Photo M-801)

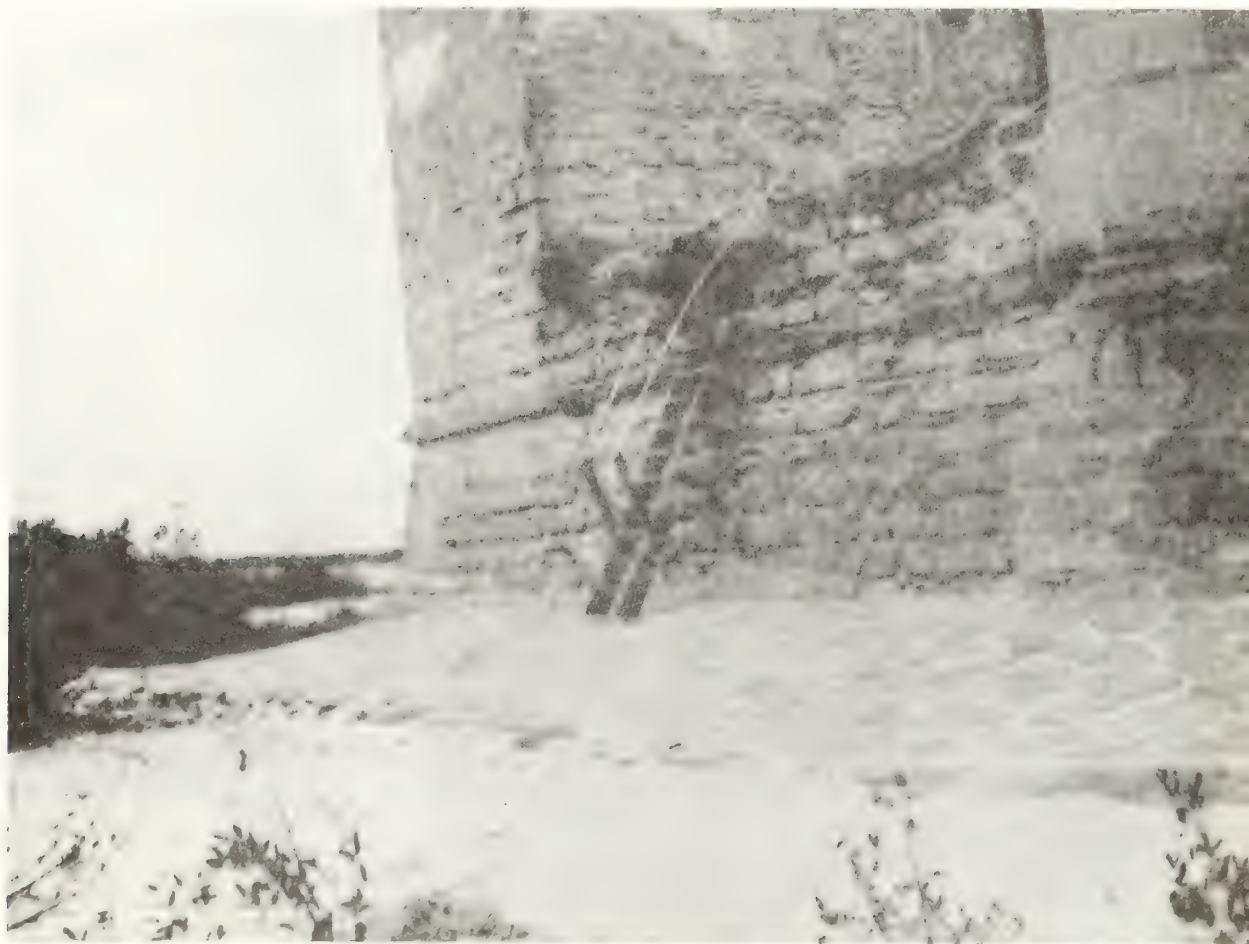
Illustration D-29

View of Entrance Through West Embrasure, circa. 1936, (Photo M-815)

The entry stair pictured here lasted only a few years before it was replaced by the more massive stair present today. It is, however, probably much more in keeping with a sense of the historic means of egress. This photograph was taken shortly after the completion of the steel bulkhead and installation of coquina pavers. Notice the cannon which was placed in the embrasure at this time.

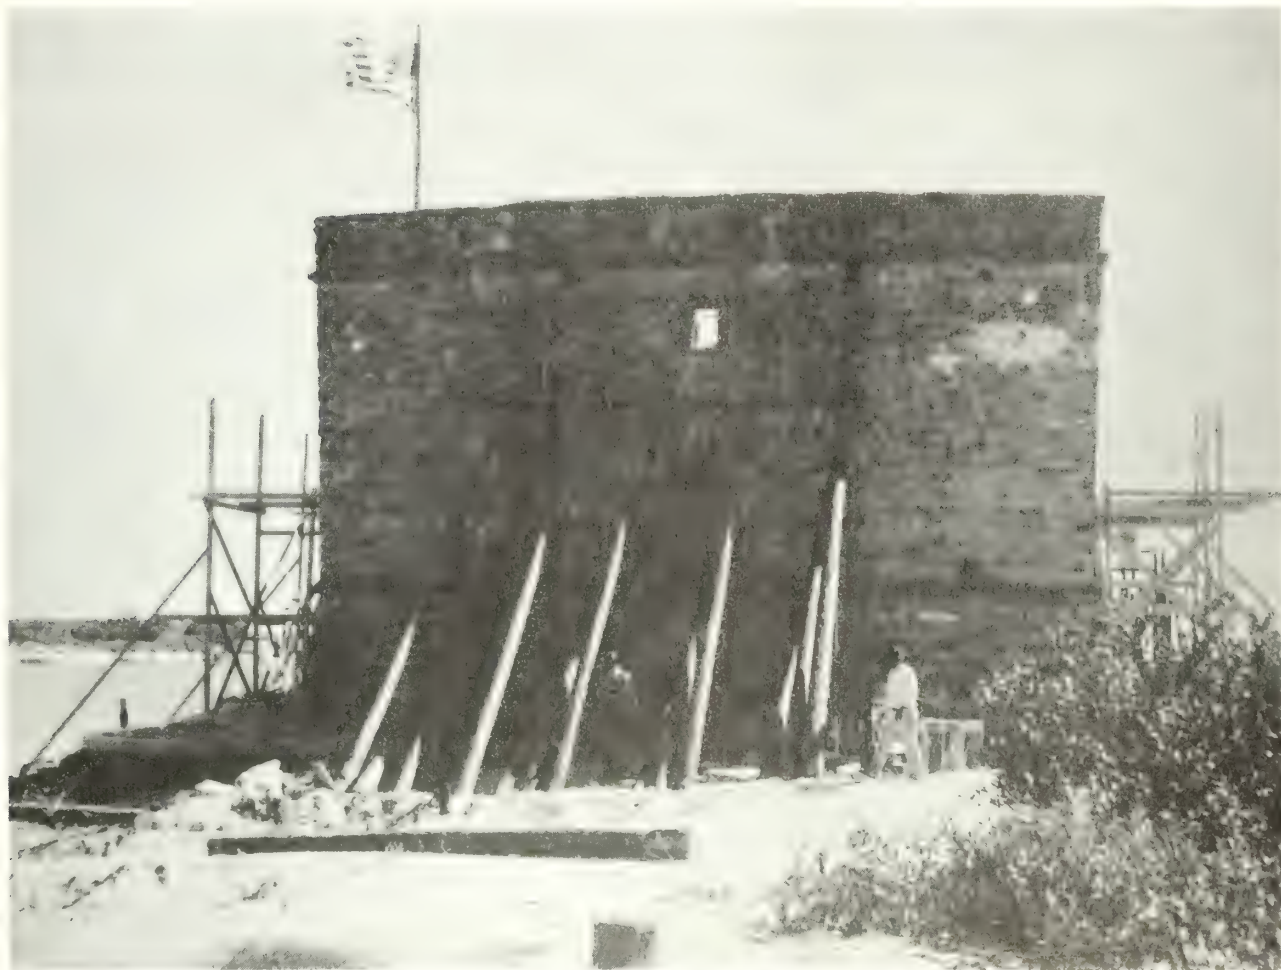
Illustration D-32

Starting in October 1938 and lasting into the spring of 1939, the tower vault reconstruction was undertaken including placement of two more north-south and the lower set of four east-west tie rods. This project apparently included the installation of a wooden floor system in the second level room.

View of Vault Stabilization Project, December 1938. (Photo M-40)

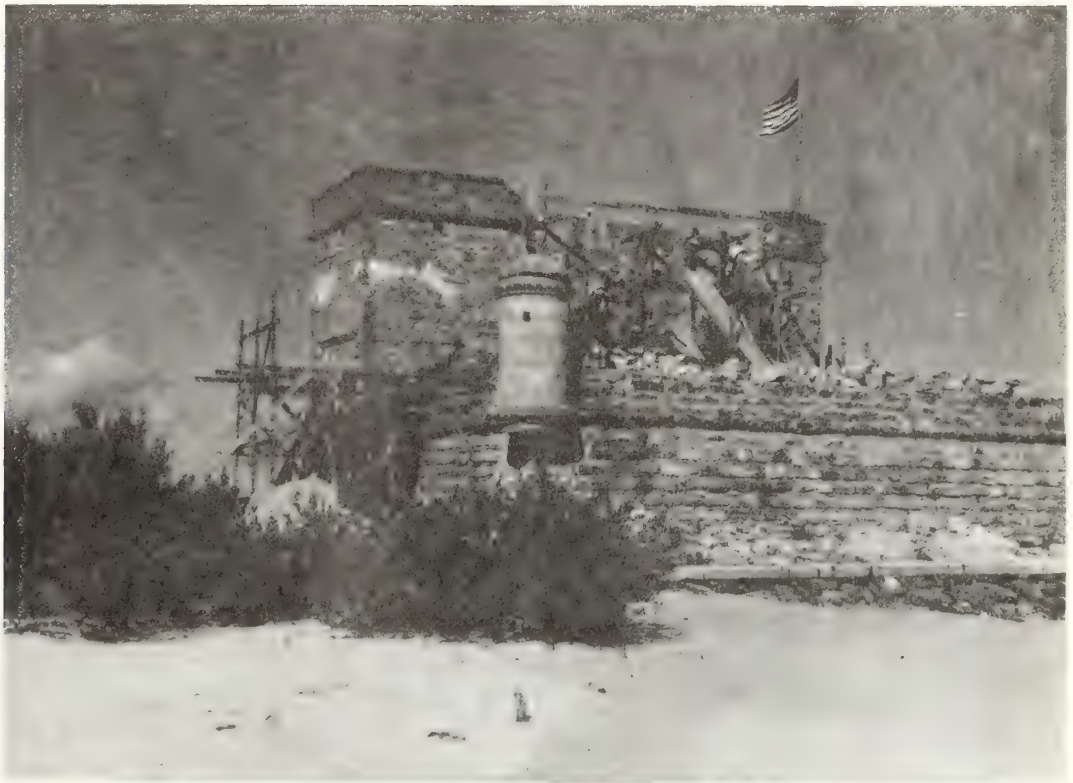
Illustration D-33

The massive bracing system pictured here was necessary as the south face of the tower and north-south tie rods were removed leaving the free-standing north wall.

View of Vault Stabilization Project, December 1938, (Photo M-39)

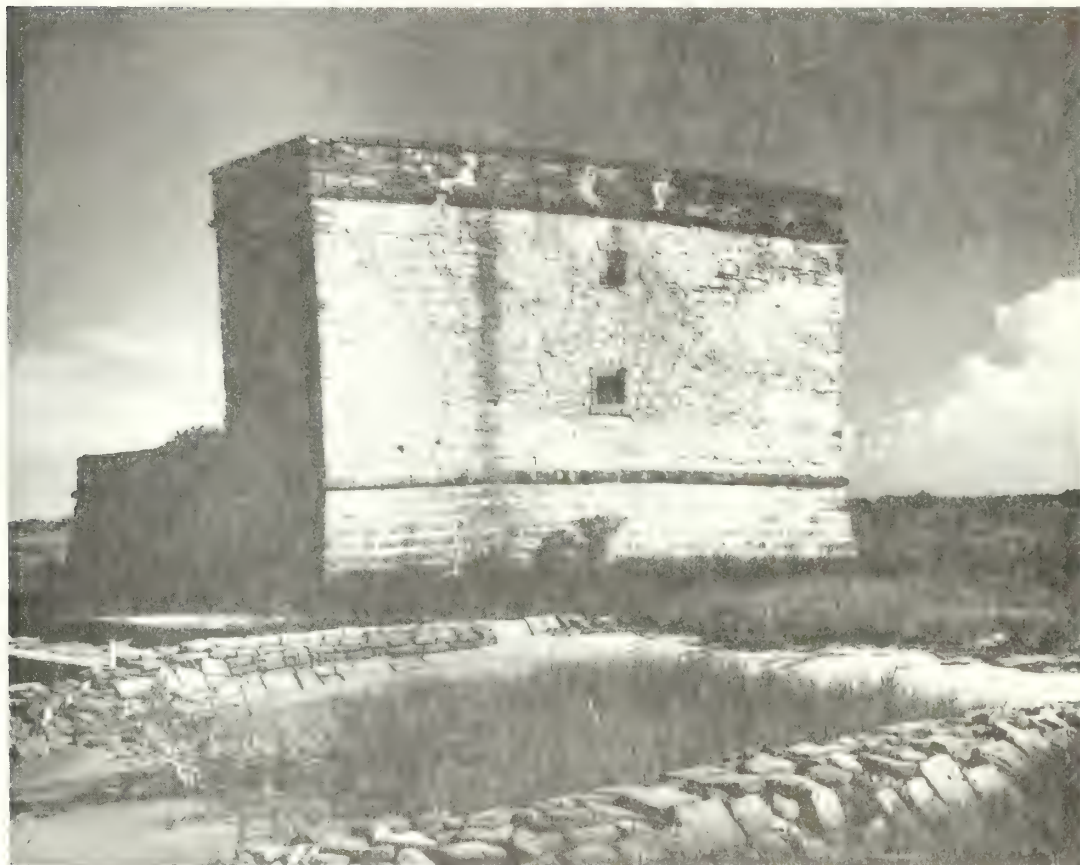
Illustration D-34

View of Fort and New Groins, circa. 1942, (Photo M-134)

This photograph shows the new goins and incomplete coquina sea wall. Notice that the paving stones placed behind the steel bulkhead are no longer present--perhaps they were used in the construction of the new shore protection features.

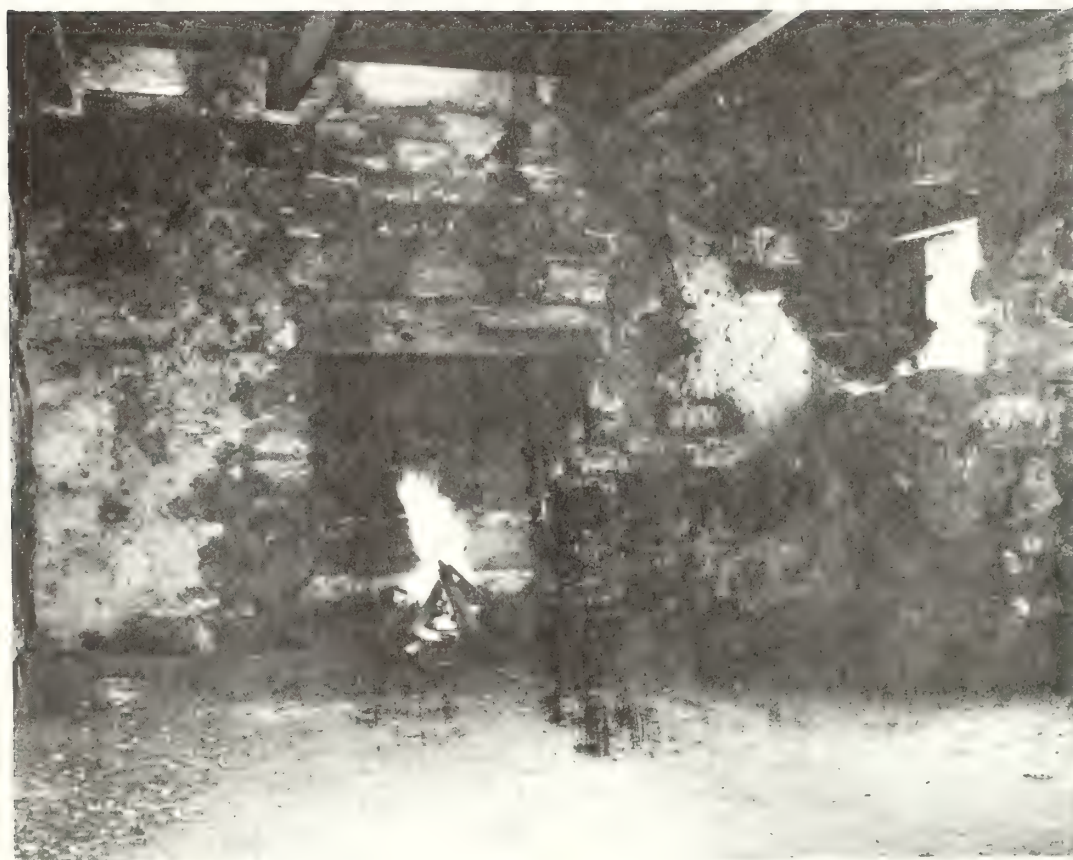
Illustration D-35

Interior View of First Floor, circa. 1940, (Photo M-442)

In this photograph it is interesting that a fire is lit; but more interesting is the use of false beams to hide the four tie rods installed in 1939. These were criticized by Historian Borresen and removed shortly thereafter.

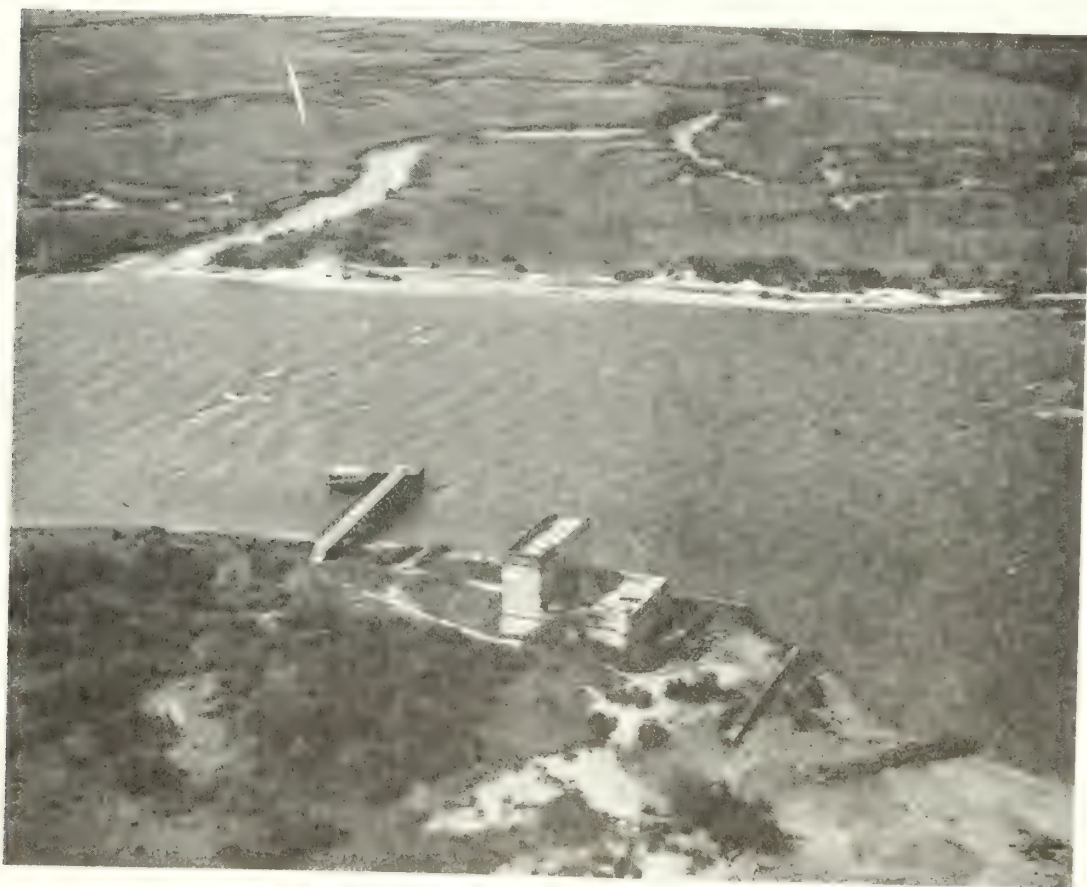
Illustration D-36

- 1941-46 Stabilization monies not allocated, war years.
- 1944 In October, a storm damaged the second coquina sea wall and the southeast corner of the fort. (Illus. D-36)
- 1945 Storm damage on southeast corner of fort given temporary repairs (backfilling erosion?).
- 1947 More storm damage reported on southeast corner to the stabilization work and erosion of fill around the fort foundation walls.

Aerial View of Fort Site After Storm Damage, October 1947, (Photo M-411)

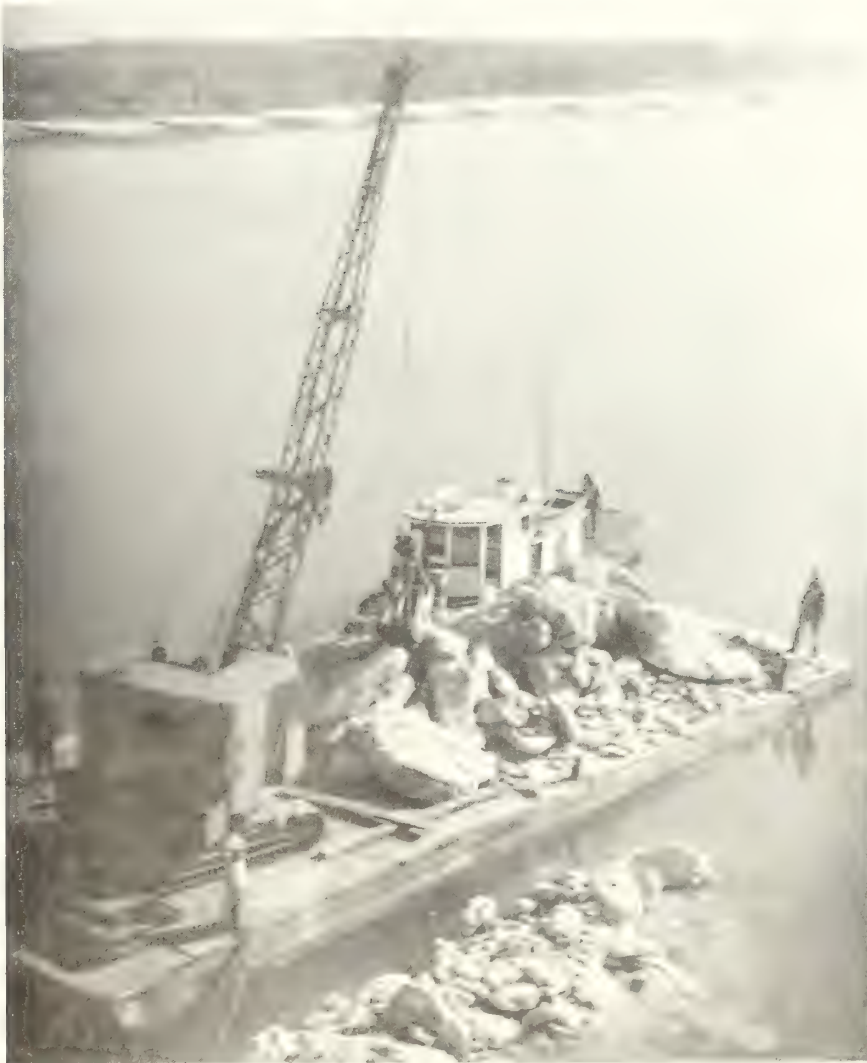
Illustration D-39

Construction of 800 Cubic Yard Groin, December 15, 1948, (Photo M-144)

Massive riprap was used to repair the southeast corner of the fort site after the storms of 1944 and 1947 removed the coquina sea wall.

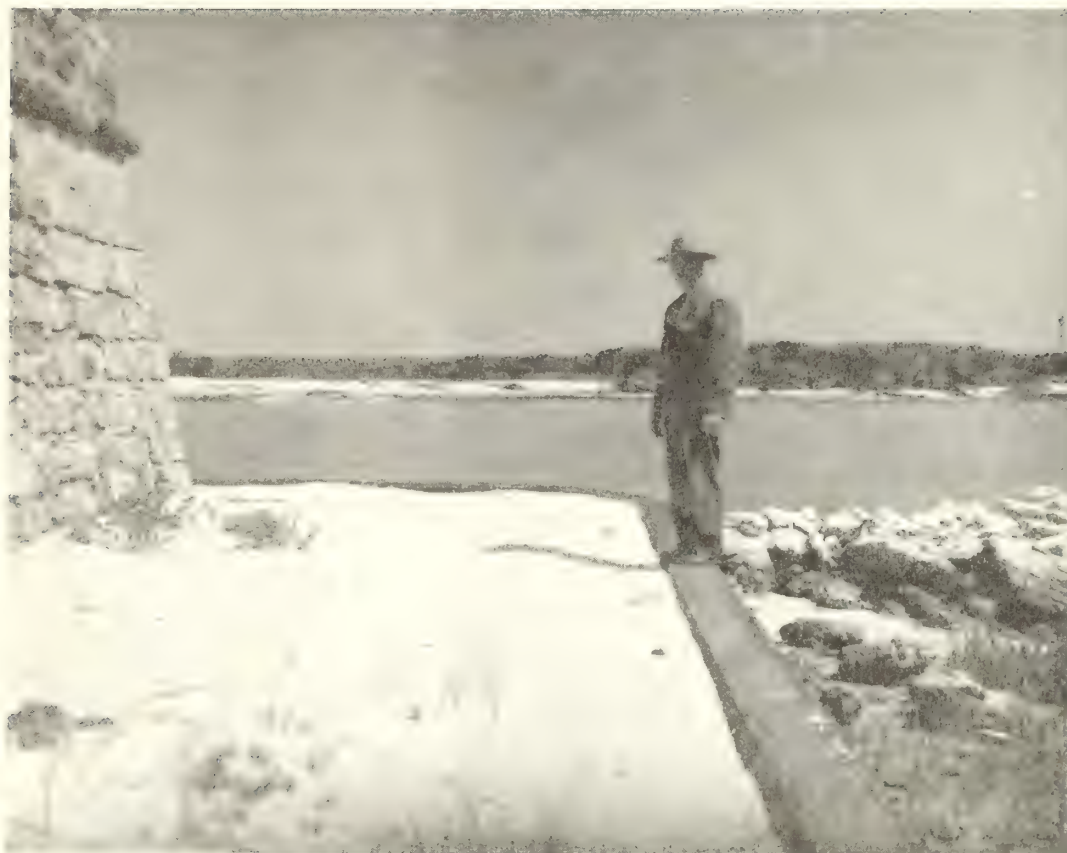
Illustration D-41

View of Backfilled Steel Bulkhead, March 23, 1949, (Photo M-157)

After the steel sheet piling was treated (Illus. D-40), backfilling was performed. However, the area between the new 800 cubic yard groin and steel bulkhead was not filled until 1966.

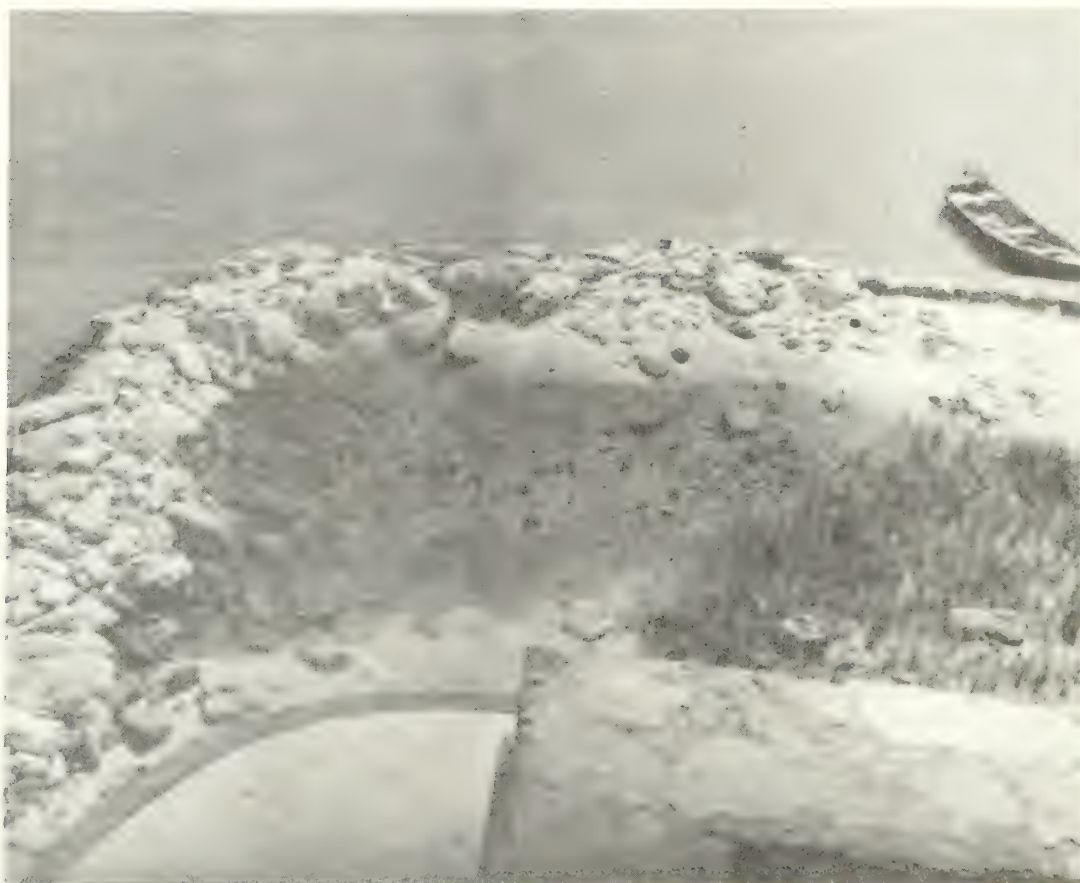
Illustration D-42

View of New 800 Cubic Yard Groin, March 23, 1949, (Photo M-154)

This massive riprap groin created an unsightly condition, but probably performed its protective function for fifteen years.

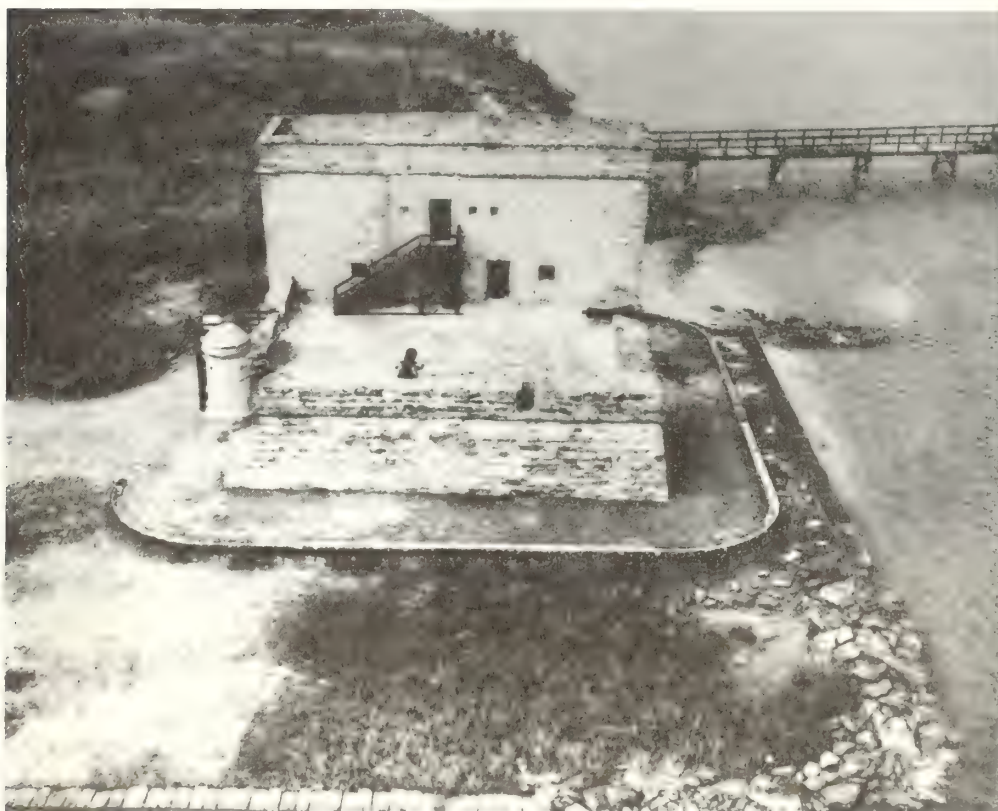
Illustration D-43

- 1950 No action documented.
- 1951-52 Unspecified masonry repairs (maintenance) performed.
- 1953-55 Unspecified maintenance continued (repointing?).
- 1956 The wharf was rebuilt at Rattlesnake Island.
- 1957-65 Unspecified maintenance continued (repointing?).
- 1965 Hurricane Dora, 1964, causes damage to shore protection systems at the fort site and knocked out the 1934 dike connecting the north and south sections of Rattlesnake Island.

Aerial View of Fort Site After Hurricane Dora, (Photo M-387)

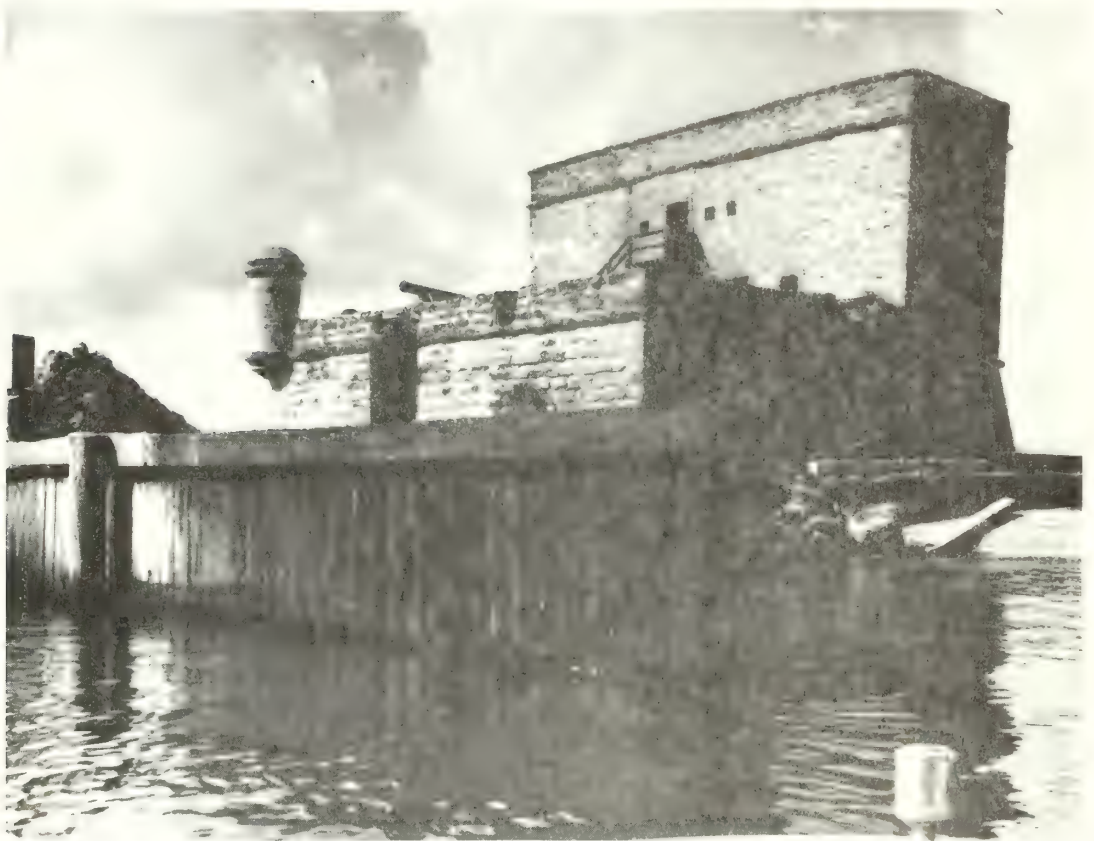
Detail View of Timber Sheet Piling, March 2, 1966, (Photo M-425)

Once installed, riprap was placed in front and on top of the timber sheet piling and the area behind it filled and sodded.

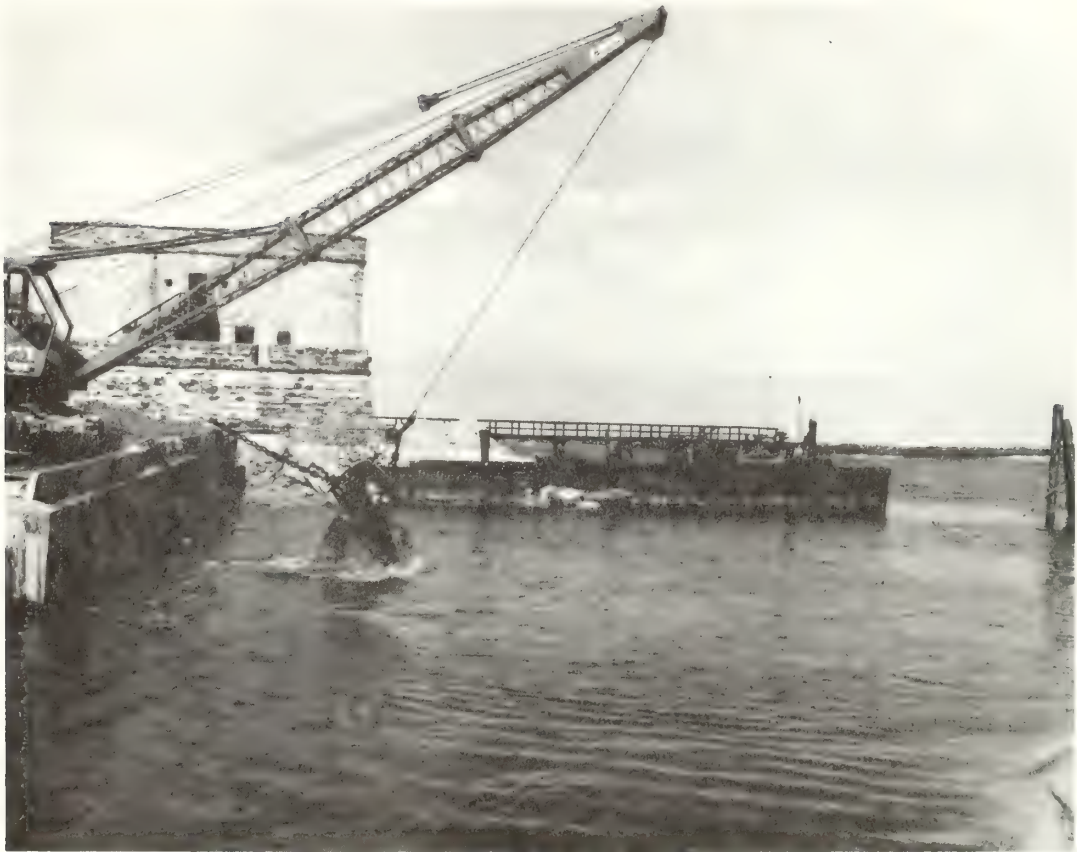
Illustration D-45

View of Backfilling Operation Behind Timber Sheet Piling, March 2, 1966, (Photo M-423)

The area between the steel bulkhead and new timber piling was filled with dredge material as shown here.

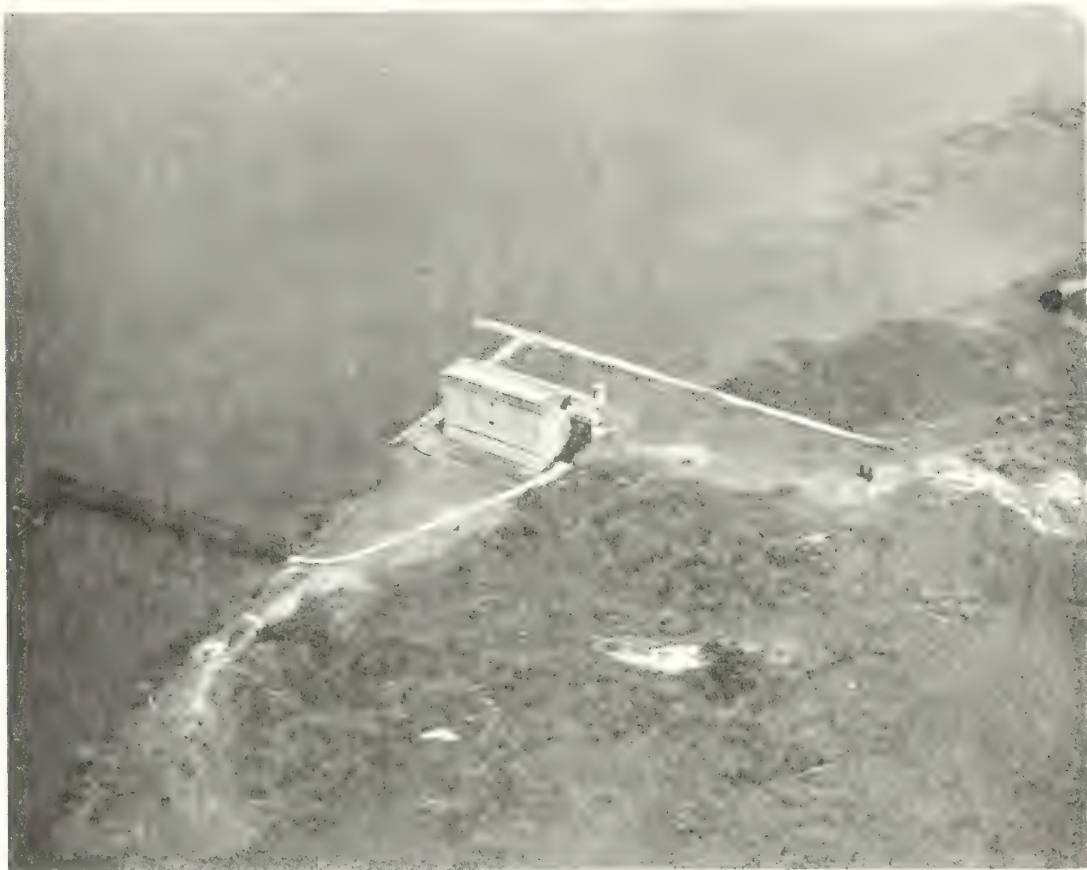
Illustration D-46

Aerial View of Fort Site, 1971, (Photo M-535)

In this photograph we see the condition created by the 1966 shore protection project. Even at a fairly high tide condition we see the presence of the small barrier island south of the fort. This sand bar seems to have formed due to the change in tidal prism resulting from Hurricane Dora's removal of the dike connecting the north and south sections of Rattlesnake Island.

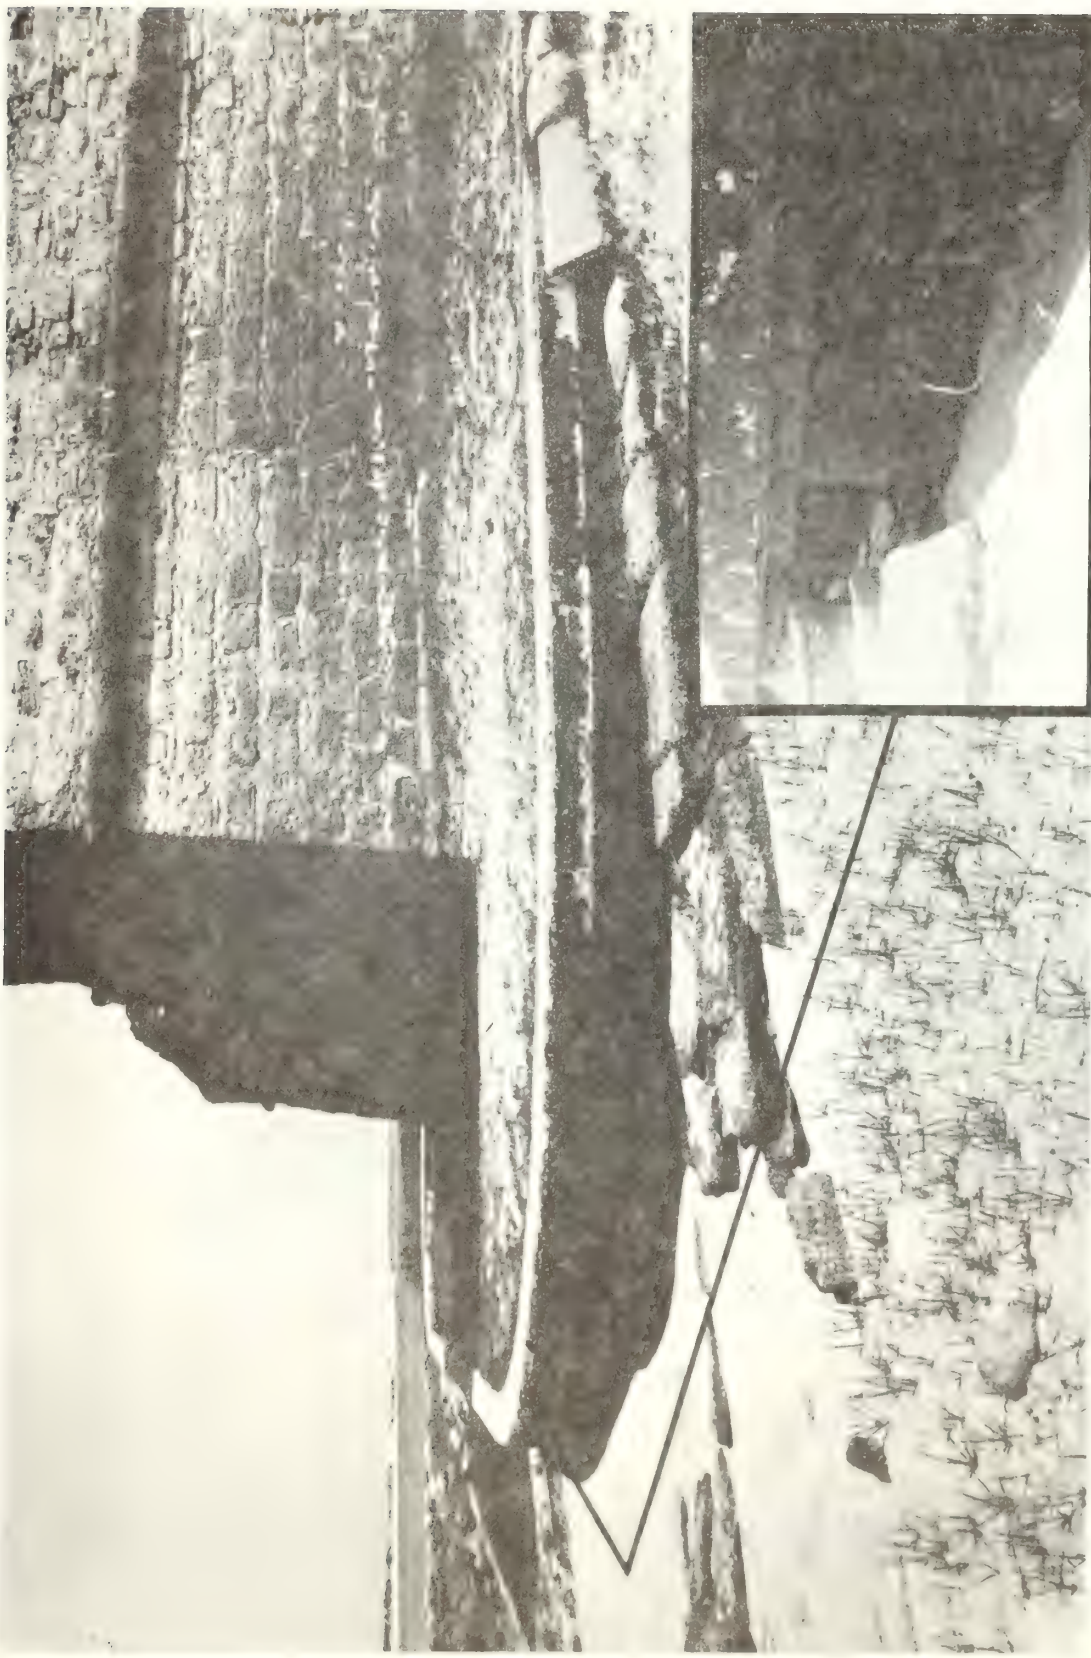
Illustration E-1

Based upon recommendations by the District Engineer, sheet piling was placed only on the south and east sides of the fort, topped by a concrete cap at elevation 4.5± above MSL. The purpose for this work was to confine the soils around the foundation and to protect the fort walls against river currents during abnormally high tides. (Purposes which have been partially superseded by later treatments.) This has worked to a certain extent, however water still washes over the concrete cap and when it does, it becomes trapped between the fort and the bulkhead after the tide has receded. Despite additional treatments performed in later years the top of the piling above grade is rusted, particularly where exposed (Illus. E-1). H-piles, driven to support the piles, are in worse condition and the top of these members are corroded through in some locations. The concrete cap is in good condition.

Detail of Steel Sheet Bulkhead

Excavate the ground on each side of the steel bulkhead to the full depth of the sheet piling and remove rust by chemical or mechanical means. Coat the steel with a protective membrane material. This action, if done on a cyclical basis, will preserve the fabric indefinitely. No action other than cosmetic finishing is required on the concrete cap. By restoring the integrity of the

steel bulkhead, soil around the fort foundation will remain confined. This will prevent scouring of the coquina fabric below grade, as well as minimizing the amount of surface erosion during storm tides.

Excavate the ground on each side of the bulkhead only to the depth of the water table (approximately 5'). Remove rust and coat steel similar to Alternative One. This action is based on the fact that the steel below the water table is constantly submerged and thus only limited corrosion occurs. Coating of the top portion of the bulkhead would prolong its life expectancy, and if done on a cyclical basis would preserve it even longer.

No action would be performed on the steel bulkhead; however, periodically fill would be piled against the bulkhead so that it will not be directly exposed to wave action. The concrete cap would be repaired as necessary. Under this alternative the remaining life expectancy of the steel bulkhead is estimated at 30-50 years.

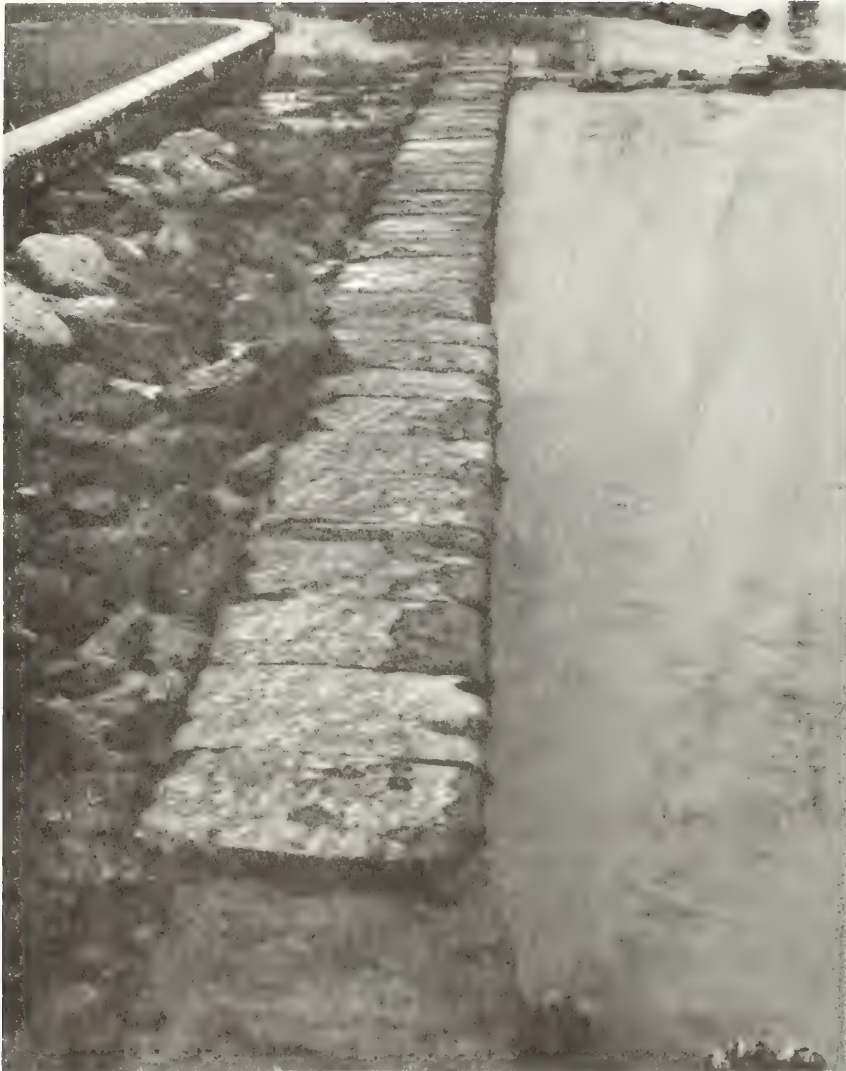
Illustration E-3

Detail of Coquina Seawall East of Fort

this will probably consist of coquina riprap placement in the form of a revetment, similar to the existing treatment at the south side of the site. Repointing of the wall will be required as well as some stone replacement.
